Subject: Submittal of the 2021 Sandia Wetland Performance Report

# 2021 Sandia Wetland Performance Report

The 2021 Sandia wetland performance report is the eighth annual performance report following the 2012 to 2014 baseline that assessed the overall condition of the wetland at the head of Sandia Canyon. Sandia wetland monitoring was performed in the context of the wetland's ability to mitigate migration of contaminants of concern (i.e., chromium, polychlorinated biphenyls [PCBs], and polycyclic aromatic hydrocarbons) detected in wetland sediments as a result of historical releases at Los Alamos National Laboratory (the Laboratory). The geochemistry and physical stability of wetland sediments, along with the extent of wetland vegetation, are the key indicators of wetland conditions. The condition of the wetland is assessed to evaluate the effectiveness of the grade-control structure (GCS) completed in 2013 at the terminus of the wetland and to monitor changes to the Laboratory's operational practices that have affected outfall volumes discharging to the wetland. This report presents the results of monitoring conducted for surface water, alluvial groundwater, and geomorphology bet

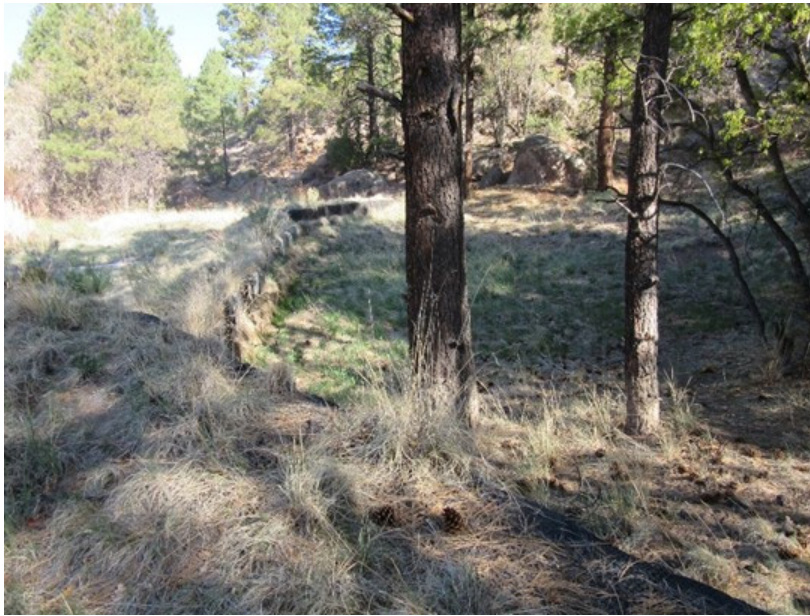
**Photo C-2.7-1 May 13, 2021 – Lower run-on cell barrier, looking west.  
Sediment level at 3 to 4 ft below top of spillway**

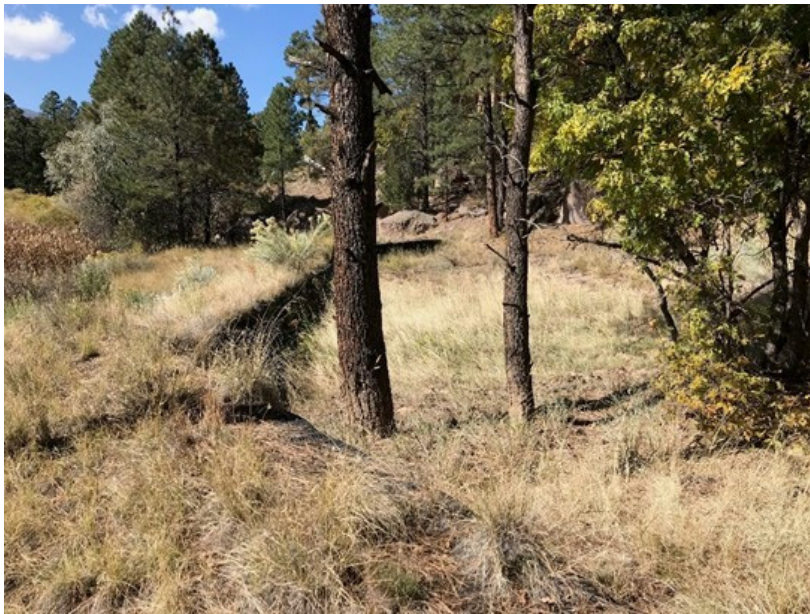
**Photo C-2.7-2 October 19, 2021 – Lower run-on cell barrier, looking west.  
Sediment level at 3 to 4 ft below top of spillway**

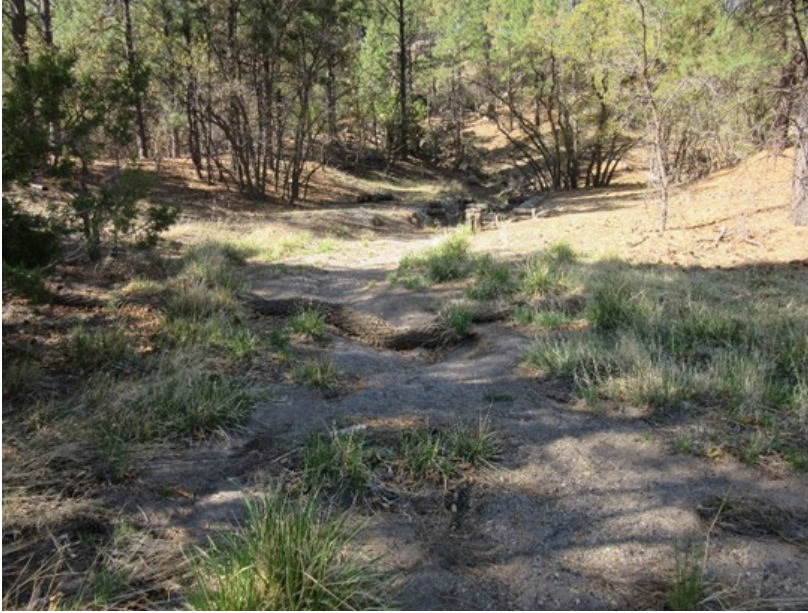
**Photo C-3.0-1 May 13, 2021 – Coir log recommended for removal to address local scour, looking south**

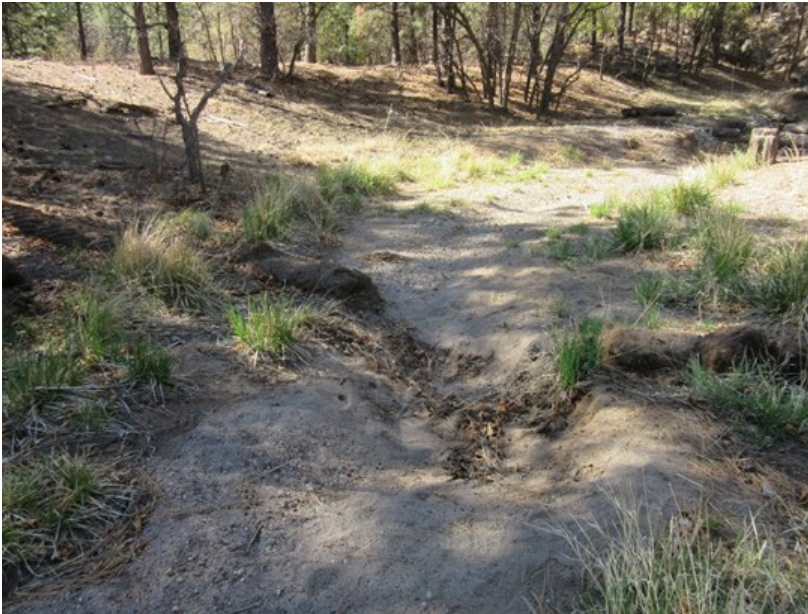
**Photo C-3.0-2 May 13, 2021 – Coir log removed, looking southeast**

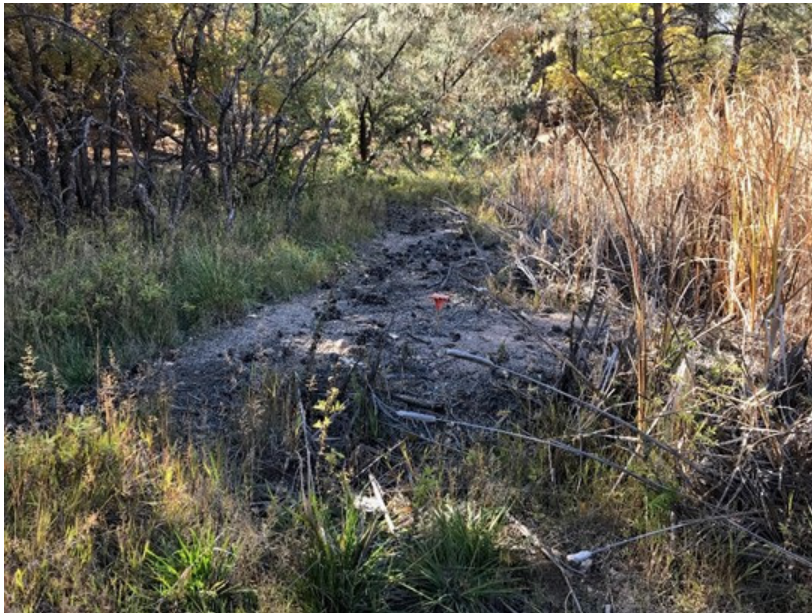
**Photo C-3.0-4 October 19, 2021 – Sediment migrating into wetlands from side drainage. Recommend controls be installed to mitigate**

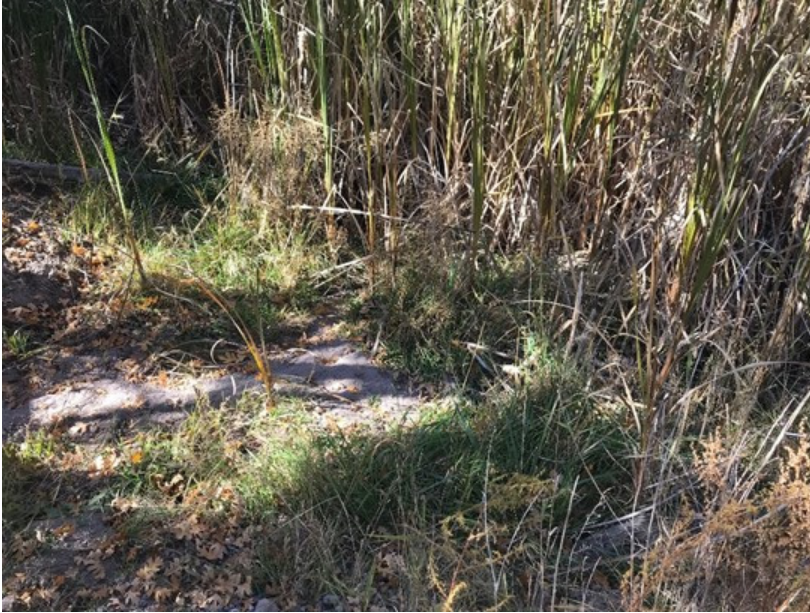
**Photo C-3.0-5 October 19, 2021 – Sediment migrating into wetlands from side drainage. Recommend controls be installed to mitigate**

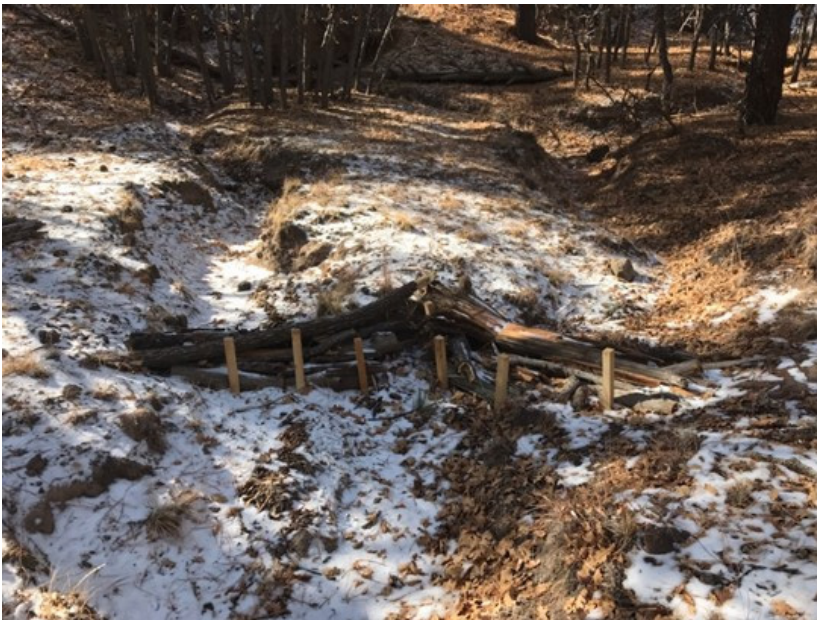
**Photo C-3.0-6 December 22, 2021 – Log berms installed to address sediment migration from side drainage**

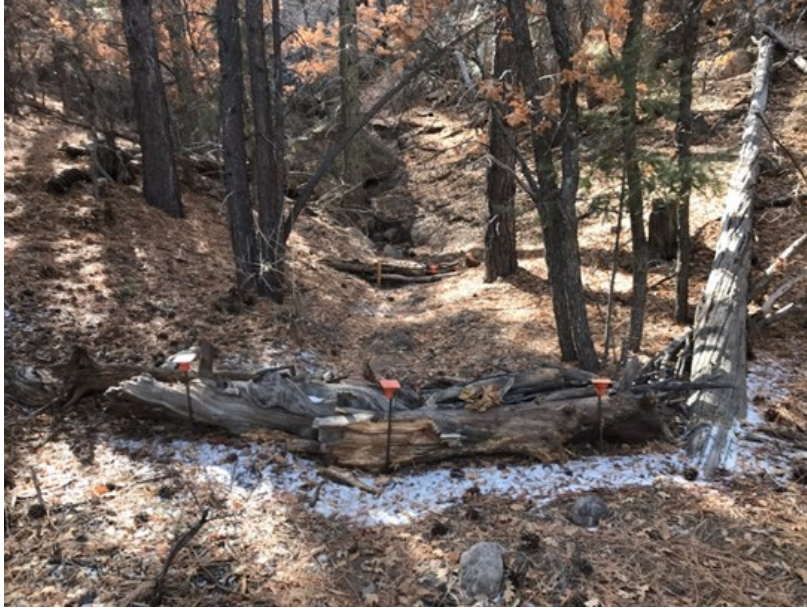
**Photo C-3.0-7** December 22, 2021 – Log berms installed to address sediment migration from side drainage

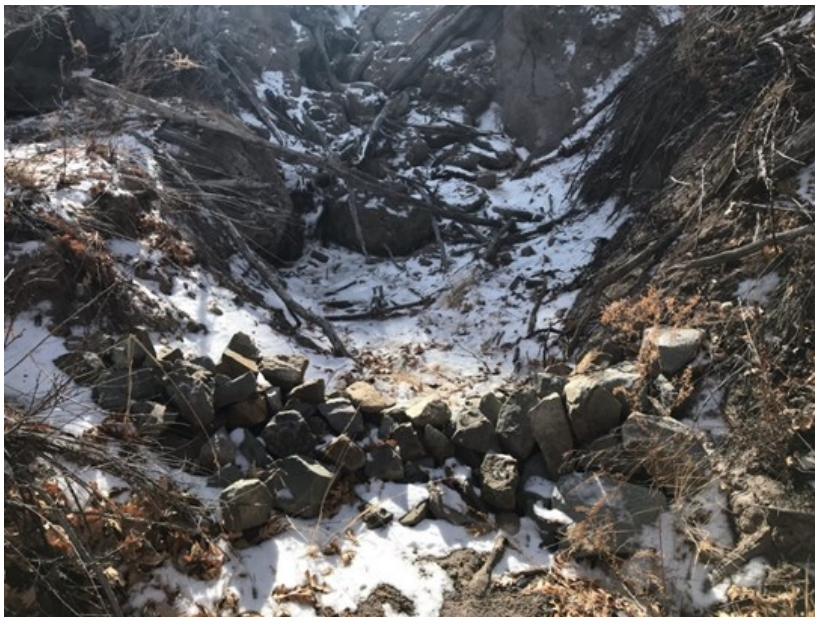
**Photo C-3.0-8** December 22, 2021 – Rock check dam installed to address sediment migration from side drainage
